RE: Site Inspection, Molycorp, Small Fry Mine, M/037/022, San Juan County, Utah

Date of Inspection: March 27 and 28, 2003  
Time of Inspection: about 4:40 to 5:10 p.m. on March 27 and 9:15 to 9:45 a.m. on March 28  
Conditions: Partly cloudy, 30's, windy  
Participants: Gary Haptonstall (URS Corporation—Reclamation Contractor) and Denice Swanke (BLM) both on March 28, and Paul Baker (DOGM)

**ATTACHMENT**  
**Inspection Date: March 27 and 28, 2003; Report Date: April 17, 2003**  
**Photographs**  
**S/037/022, Small Fry Mine, Molycorp**

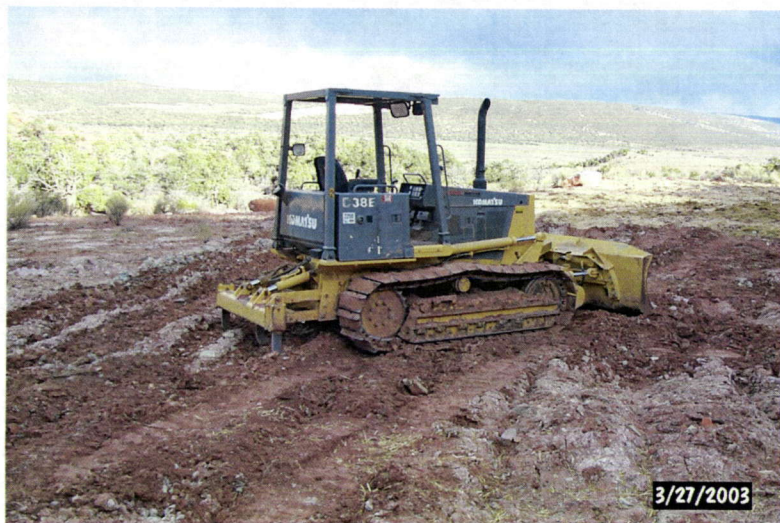
The contractor had been using a small dozer with rippers (Photo 1) to scarify the surface prior to seeding. Most of the area had been seeded and mulched with certified noxious weed free straw, and the contractor was working to complete this work. Views of various parts of the reclaimed area are shown in Photos 2 through 4.

**Photo 1. The dozer being used to rip the reclaimed area prior to seeding.**

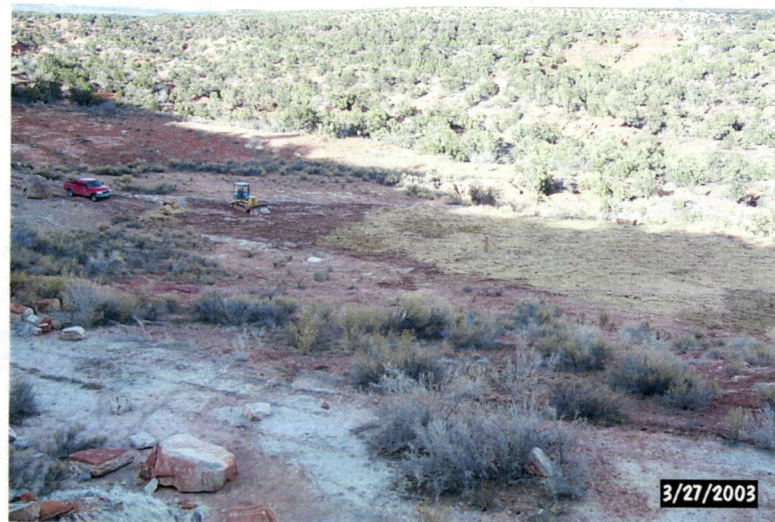
**Photo 3. An overview of part of the main pad area.**

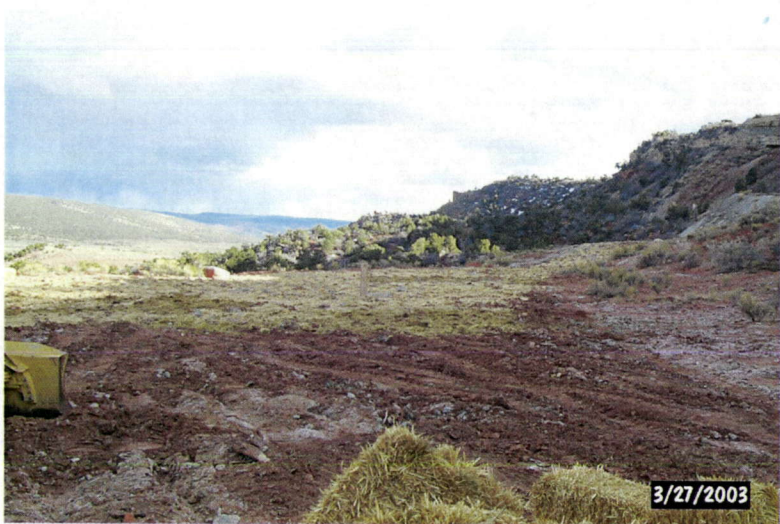
**Photo 2.**

As can be seen in Photo 2, the final prepared surface is not extremely rough, but because most of the site is not too steep, I believe the surface preparation is adequate.

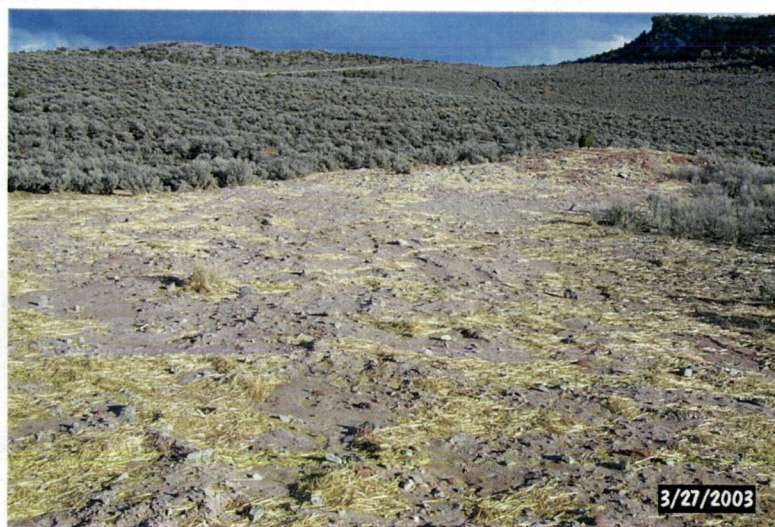
The area shown in Photo 4 is where there had been a ventilation shaft. This area had not been scarified, and the surface was well crusted. I told Mr. Haptonstall I felt little if any seed would grow in this area if it was not scarified and suggested this ought to be done. It appears the soil may have a high clay content, so revegetation in this area may be difficult even with proper seedbed preparation.

**Photo 4. The area near the ventilation shaft.**

Although it may be difficult for vegetation to become established in the area of the vent shaft, it should be ripped to break the crust and allow the seed some chance to grow.
